Resorptive Lesion

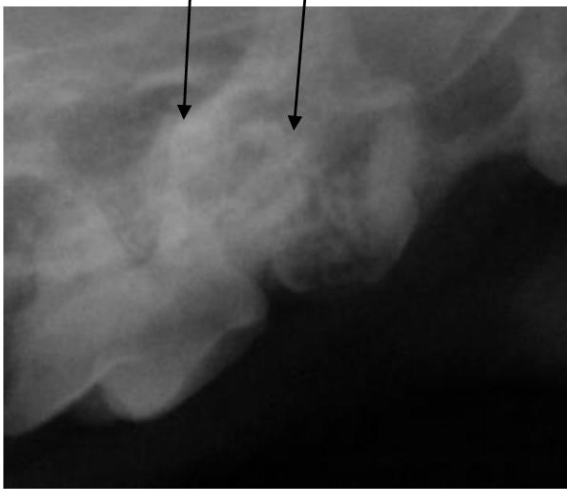
Roots of teeth that are being resorbed by the body

This is a lesion where the tooth breaks down from the cementum layer of the tooth. This is the layer of the tooth that holds the root to the bone. It will then progress and spread throughout the tooth, either dissolving the root or causing a weakness in the crown of the tooth (the part of the tooth you can see). These are found commonly in cats, and we are now starting to see more of these lesions in dogs. Unfortunately, the only way to cure these lesions is removal of the tooth

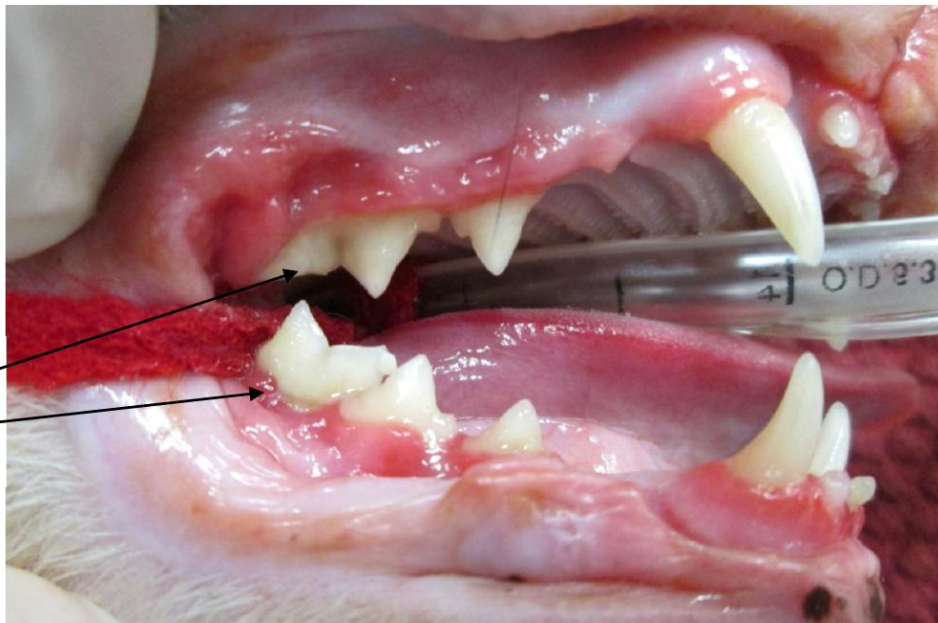
Suspected teeth with resorptive lesions
