Resorptive Lesion

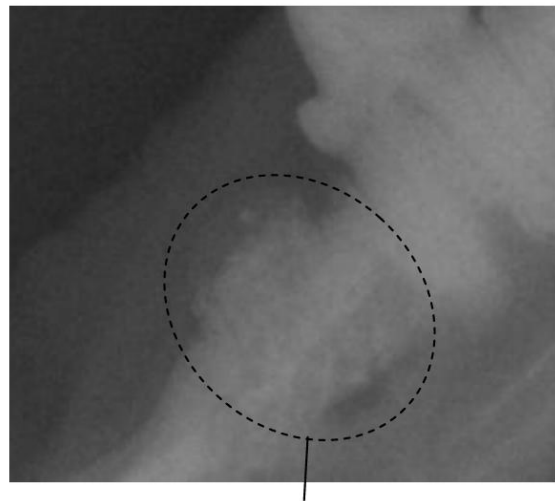
Tooth that has almost been completely resorbed
